Date
November 2nd, 2023
Submitted By
Anna Weiss-Pfau, AIC-PA, Principal Conservator 630.308.0390
Maria Paras, Associate Conservator
3rdcoastconservation@gmail.com
L.Liparini Studio ♦ Third Coast Conservation, LLC

Analysis and Repainting of the Stempost and Sternpost of the *Viking* ship

This project included the conservation assessment, analysis, and treatment of the dragon stempost and sternpost of the *Viking* ship. The *Viking* ship was fabricated in 1893 in Sadefjord Norway by shipbuilder Christen Christenson. The ship is a replica of the *Gokstad* ship, which was built in 890 at the height of the Viking era and found and excavated by the University of Oslo. The ship is now in the University's Viking Ship Museum, which presumably would have been where Christenson would have gone to study the ship in order to create a copy. The *Gokstad* ship excavation however did not unearth the stempost and sternpost of the ship, so this dragon head and tail would have been a copy of something else. It is not currently known what Christenson would have copied these from, but this is an area of potential research.

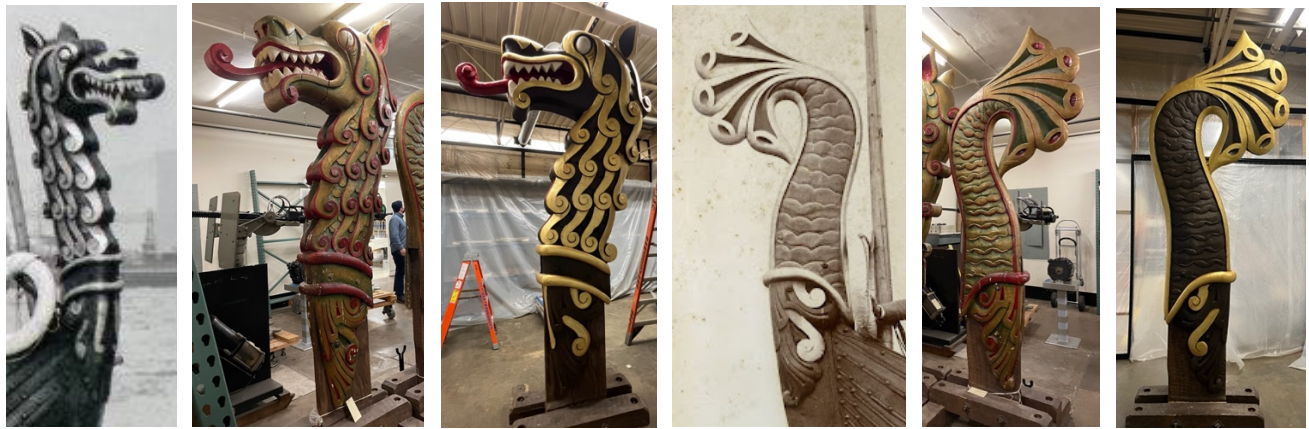
Left 3 images: Stempost – Comparison of original 1983 appearance, 2022 before treatment, 2022 after treatment
Right 3 images: Sternpost-- Comparison of original 1983 appearance, 2022 before treatment, 2022 after treatment

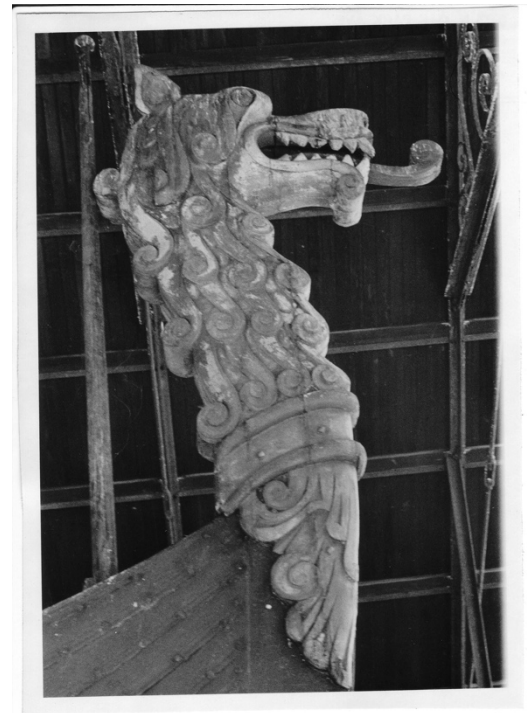
1977 In disrepair. The image to the right shows the stempost in Lincoln park, with substantial paint loss, cracking, and weathering, as well as areas of incomplete forms.

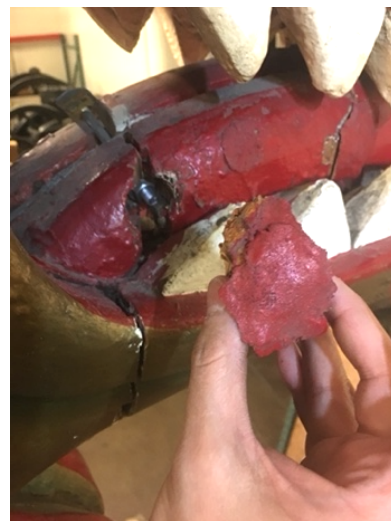
Update: It was noted during treatment that the tongue was also not structurally stable as it was being held in place with a cantilever with hardware. Ethafoam was in place to help hold the tongue up. The hardware holding the tongue in place was unable to hold the weight as some of the material had been lost. This hardware was modern, appearing stainless steel. The hardware was held in place by one of two types of putties found throughout the object.

- The putty in this area was an orange, crumbly material. Since it was added on top of the hardware, it is assumed that any paint layer found on top of this putty was not original and likely part of a later restoration than the one done in the 1920's.
(see image to the right)

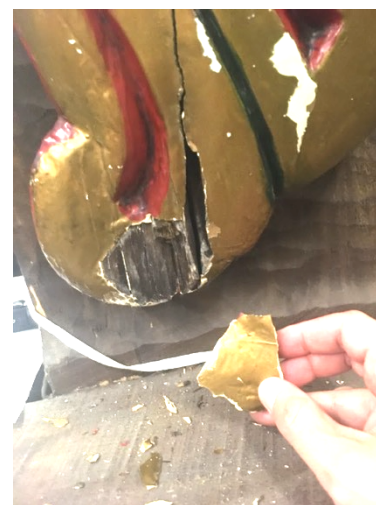
A second form of putty, a smoother, off-white putty that appeared fairly stable was also found throughout. This putty was also found to cover areas of paint (such as the likely original red paint on the chest), as well as being used to complete forms in areas where the wood had degraded substantially.

This reinforced the conservator's belief that a significant amount of the original paint scheme as well as some of the original carved forms were no longer present.

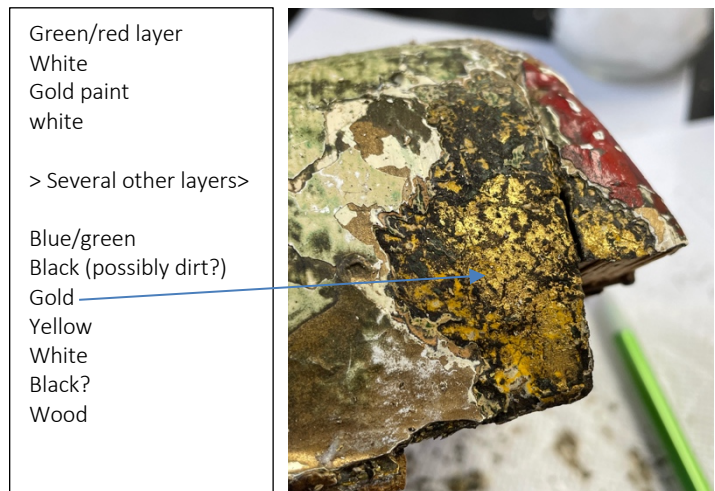
A gold layer was revealed below many layers of paint. The layers below it appear to be preparatory layers of yellow and white.

Later analysis of samples from this fragment actually indicated another very thin gold layer below all of these layers, directly on the wood.

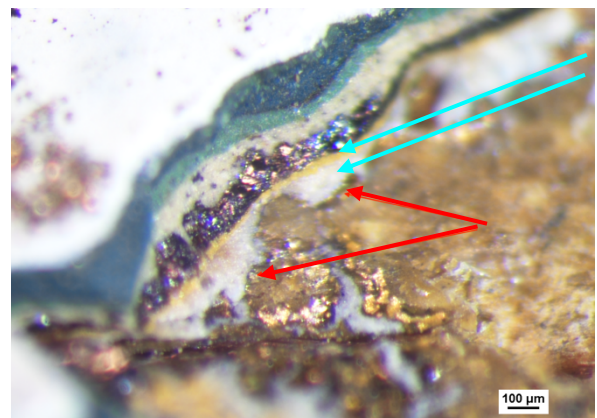
Two layers of lead based paint on top of this layer were white and yellow, with a shimmery layer above it. To the conservator, this indicates that what was found was the original gold layer directly against the wood, and the scheme of white and yellow prep layers below a shimmery layer *above* the gold layer indicates the 1920's restoration.

Red arrows point to where the original gold layer was found directly against the wood, below where the white and yellow lead layers are (blue arrows).

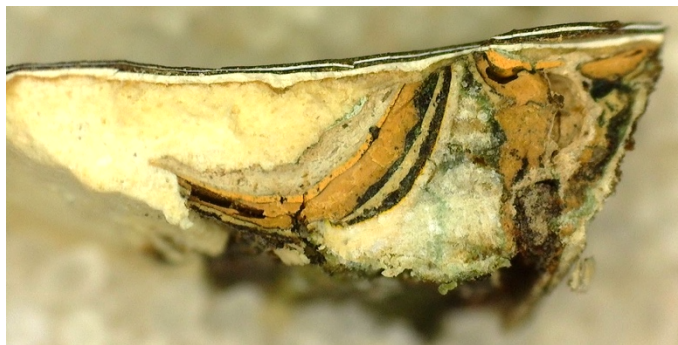
Example of a thick section of paint, where many layers and fillers/putties are overlapping. Areas like this will create confusion in analysis and identification.

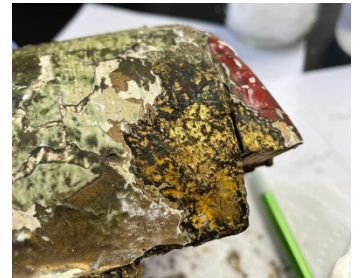
The gold in the image to the right had a primer layer below and was likely from the 1920's restoration, as it had the same yellow primer below the gold layer that was also present on areas of the tail that were supposed to appear dark but were gilded. This combination signals the 1920's restoration. In areas where the gold is directly on top of wood then indicates the original gold color scheme- but much of this could only be found under the microscope.

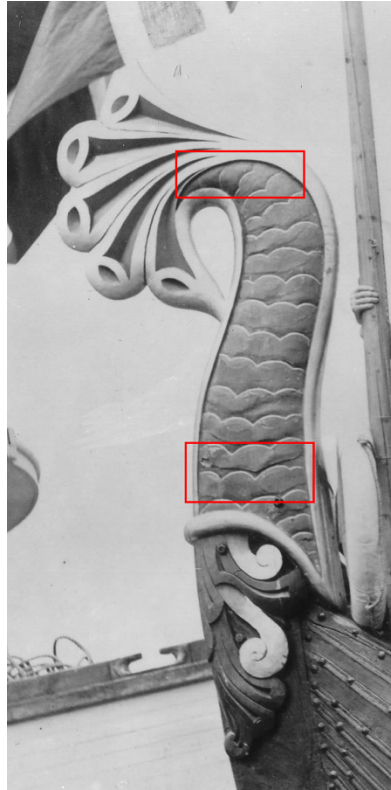
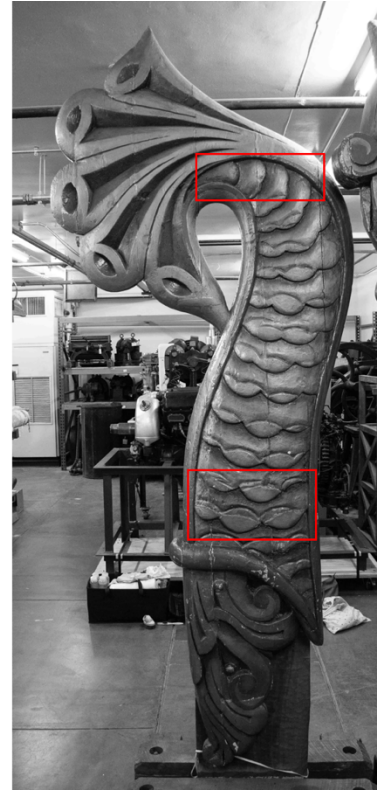
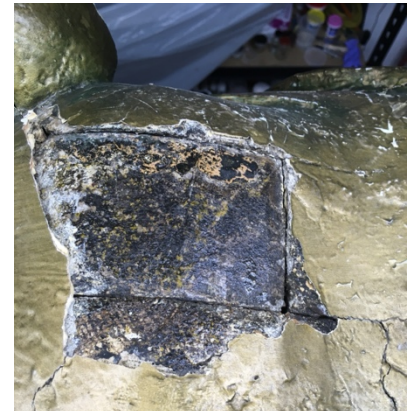
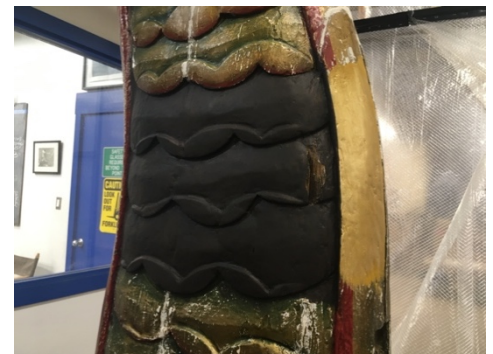
During conservation (post sampling/analysis) however, a large area of a putty/paint area on the top of the head became loose, and revealed a large section of a black material right up against the wood. The wood grain is also visible through the black material, consistent with how the wood grain appears in images from 1893.

A black paint layer was also found amongst the layers throughout this object, none of which appeared directly on top of the wood like this area and the area on the detached fragment – thus it was determined this was likely the original black layer and not from a later restoration.

In conversation with Friends of the Viking ship, it was decided to go more brown in tone rather than purely black, due to comparisons of known black elements in photography at the time and the visibility of the wood below the black layer. It is known that photography of the 1980's is not perfectly comparable to current standards, and light angles, shading, light refraction and filters will all impact how the image appears. The brown hue felt more true to a possible black impregnated wood surface. Additionally, in comparison to how the rest of the Viking ship appears now, this would be more consistent.

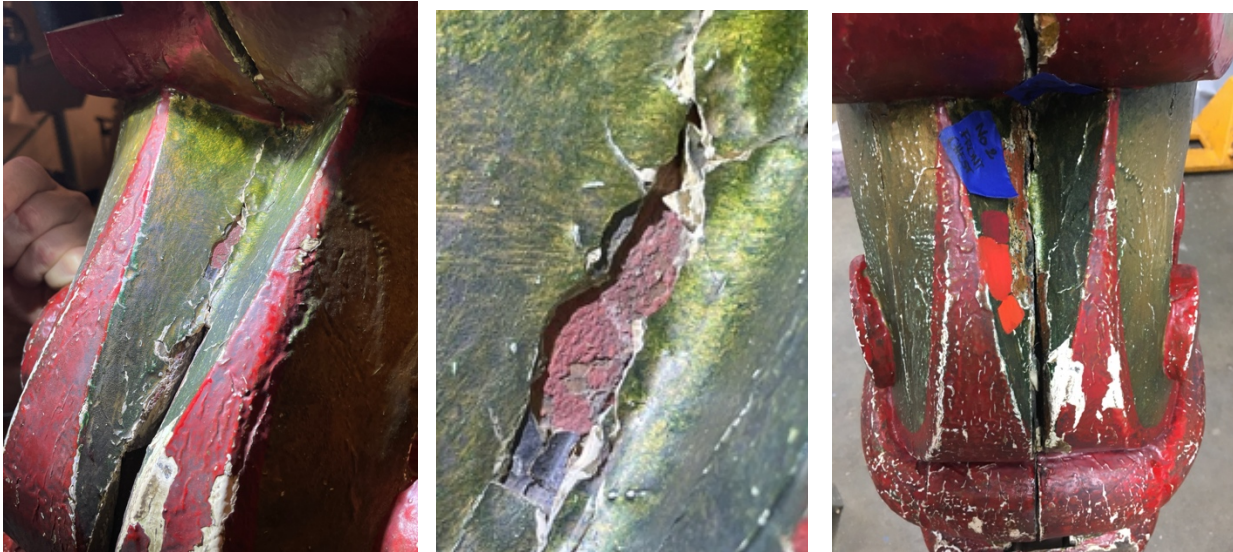
Finding a **chalky, vivid powdery red** directly on the wood surface on crevices of chest was surprising. There was also 1 smaller area on the back of the head, indicating this red may have been applied elsewhere, however unfortunately the conservators were not able to find any additional areas- leaving this a possible avenue of further exploration during a future treatment.

Left: Location of the excavated area on the chest where the red was found.
to find the white layer below on top of the wood.

Middle: Detail of the chalky red layer on top of the wood, underneath putty. Right: Red test colors to match the original red. It should be noted that cinnabar does color shift over time.

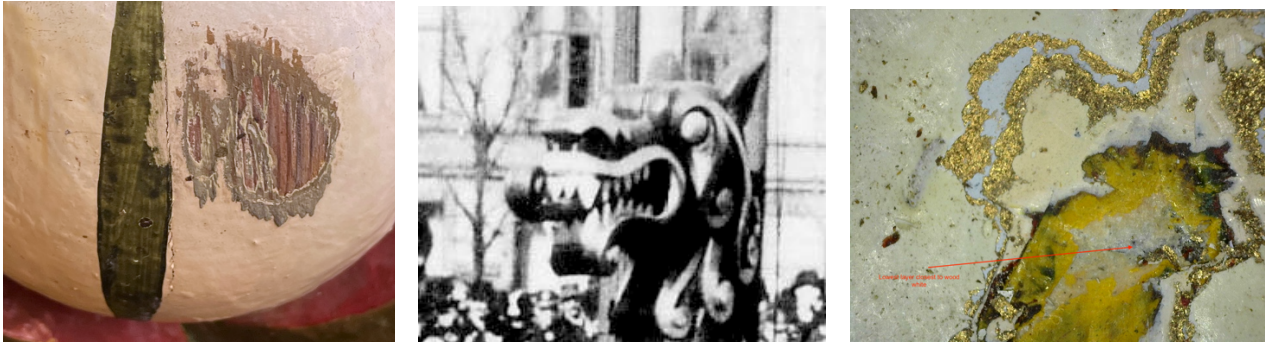
Left: Excavation of the eye to find the white layer below on top of the wood.

Middle: Dragon during the departure from h norsbryggen Kristiania, demonstrating no evidence of any lines within the eyes.

Right: Photomicrograph of the excavation of the layers of the eye within a crevice. In this photograph you can see at least 5 layers of different whites, and at least 2 layers of gold paint, as well as red, yellow and teal campaigns.

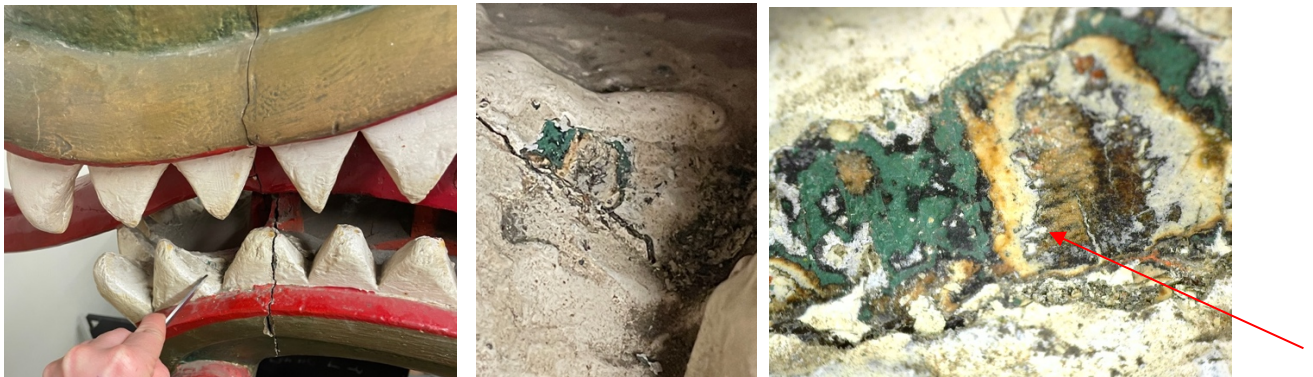
Left: One area of excavation of paint layers on the teeth. Middle: Detail of excavated area. Right: photomicrograph of the excavated area of the teeth. Note many different paint colors, with red arrow pointing to white layer on the wood

The teeth were covered in a yellowed varnish, so the varnish was knocked back with a bit of sandpaper during cleaning, and the teeth toned with the SoFlat Matte whites to help make them more brilliant, while still allowing the varnish to peek through to allow them an aged appearance.

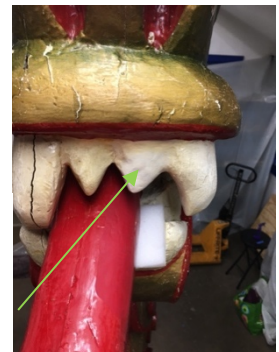
The green arrow points to the white tooth used as a test for the color.

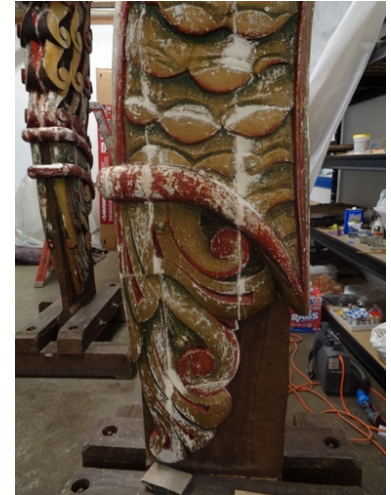
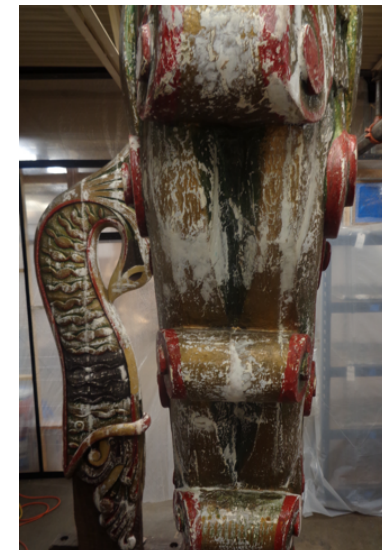
During treatment images of sternpost and stempost with white fills
