Date
November 2nd, 2023
Submitted By
Anna Weiss-Pfau, AIC-PA, Principal Conservator 630.308.0390
Maria Paras, Associate Conservator
3rdcoastconservation@gmail.com
L.Liparini Studio ♦ Third Coast Conservation, LLC

Analysis and Repainting of the Stempost and Sternpost of the *Viking* ship

This project included the conservation assessment, analysis, and treatment of the dragon stempost and sternpost of the *Viking* ship. The *Viking* ship was fabricated in 1893 in Sadefjord Norway by shipbuilder Christen Christenson. The ship is a replica of the *Gokstad* ship, which was built in 890 at the height of the Viking era and found and excavated by the University of Oslo. The ship is now in the University's Viking Ship Museum, which presumably would have been where Christenson would have gone to study the ship in order to create a copy. The *Gokstad* ship excavation however did not unearth the stempost and sternpost of the ship, so this dragon head and tail would have been a copy of something else. It is not currently known what Christenson would have copied these from, but this is an area of potential research.

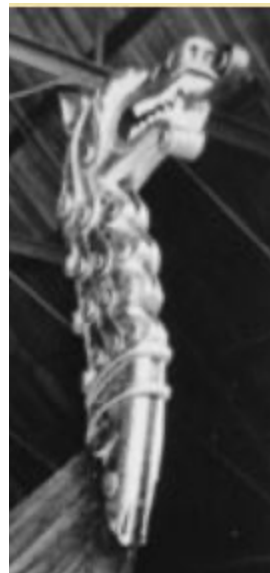
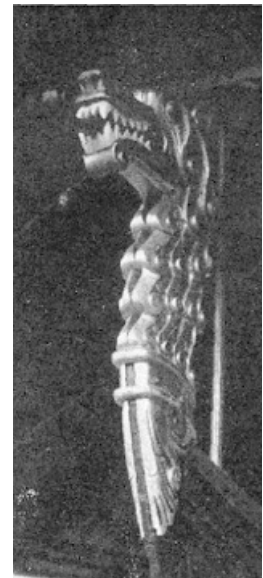
1977 In disrepair. The image to the right shows the stempost in Lincoln park, with substantial paint loss, cracking, and weathering, as well as areas of incomplete forms.

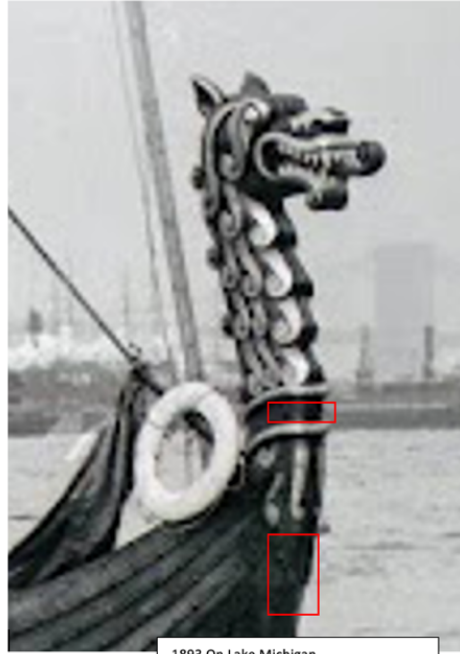
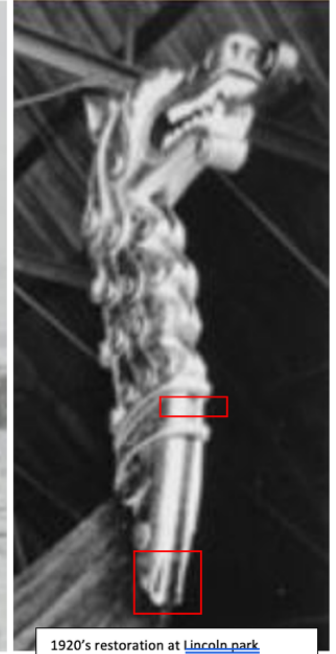
Through SEM/EDS analysis from McCrone, a gold layer found directly on top of the wood surface of the detached curved element of the back of the dragon stempost, was in fact real gold in flake form, thus applied as a leaf.

The gold in the image to the right had a primer layer below and was likely from the 1920's restoration, as it had the same yellow primer below the gold layer that was also present on areas of the tail that were supposed to appear dark but were gilded. This combination signals the 1920's restoration. In areas where the gold is directly on top of wood then indicates the original gold color scheme- but much of this could only be found under the microscope.
